МАГІСТЕРСЬКА ДИСЕРТАЦІЯ

на тему: Напружено-деформований стан в зоні вершини магістральної тріщини в обшивці фюзеляжу пасажирського літака

The object of the work is the skin with main crack for passenger aircraft.

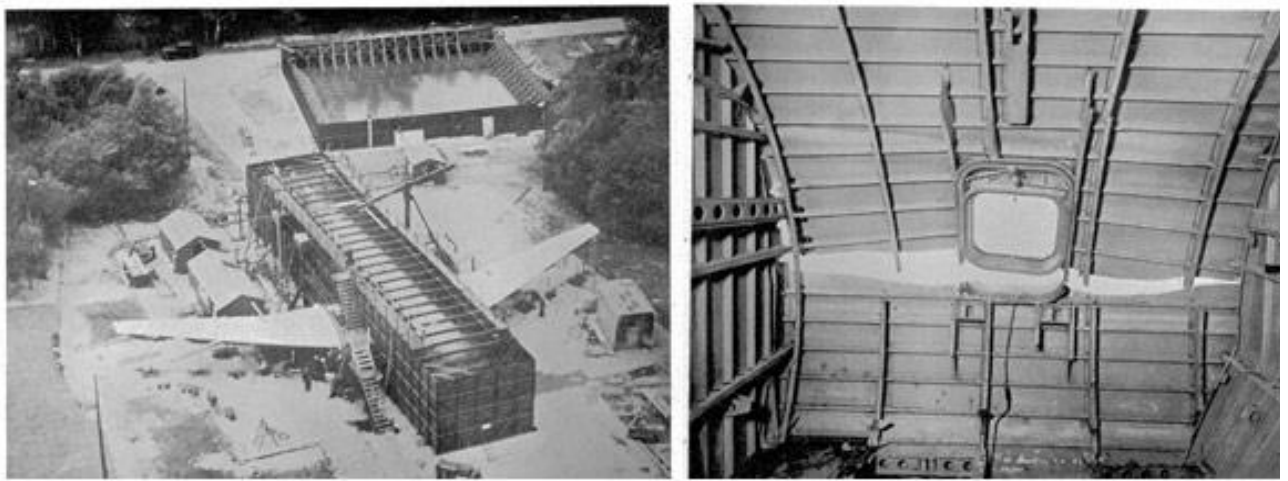
Figure 1.1.3 Comet G-ALYU in the water tank for pressure tests. The fuselage failed at a corner of a square forward escape hatch window.

G-ALYU had undergone 1,230 pressurized flights before testing and 1,830 tank "flights" before the fuselage failed at the corner of a square forward escape hatch window. This failure was the pivotal evidence needed to turn the direction of the investigation towards fatigue. A scale model was next created to test the theory of fatigue failure of the fuselage at a window corner. The results were then mapped to the crash site near Elba, and a new search area created. At this new location, the aircraft's Automatic Direction Finder (ADF) windows, also square, were recovered within hours. The ADF windows are on the very top of the fuselage, just forward of the wings. This piece of Elba wreckage, containing the two ADF windows and adjacent material bore the "unmistakable fingerprint of fatigue," and was determined to be the first fracture of the Elba crash.

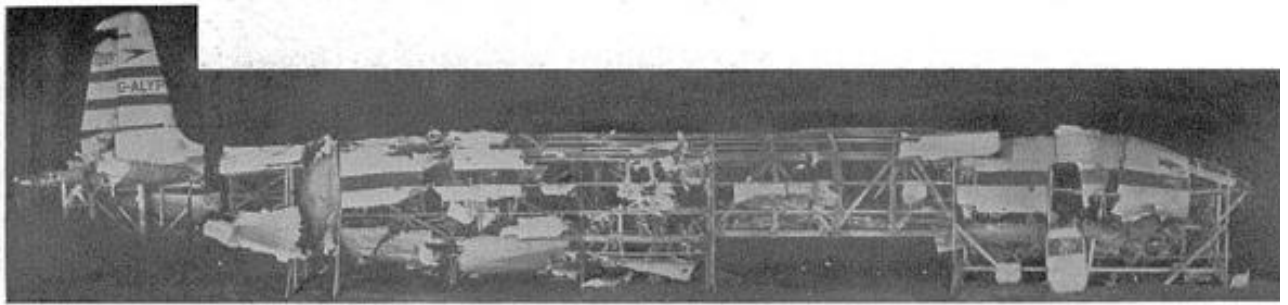
Figure 1.1.4 Reconstruction of the Elba fuselage wreckage recovered.

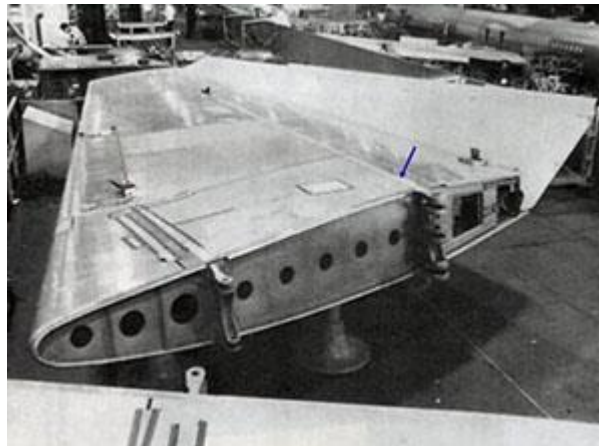
Figure 1.2.1 Photo of right hand stabilizer in jig, showing clevis attachments at the front and rear spars. Photo taken from accident report

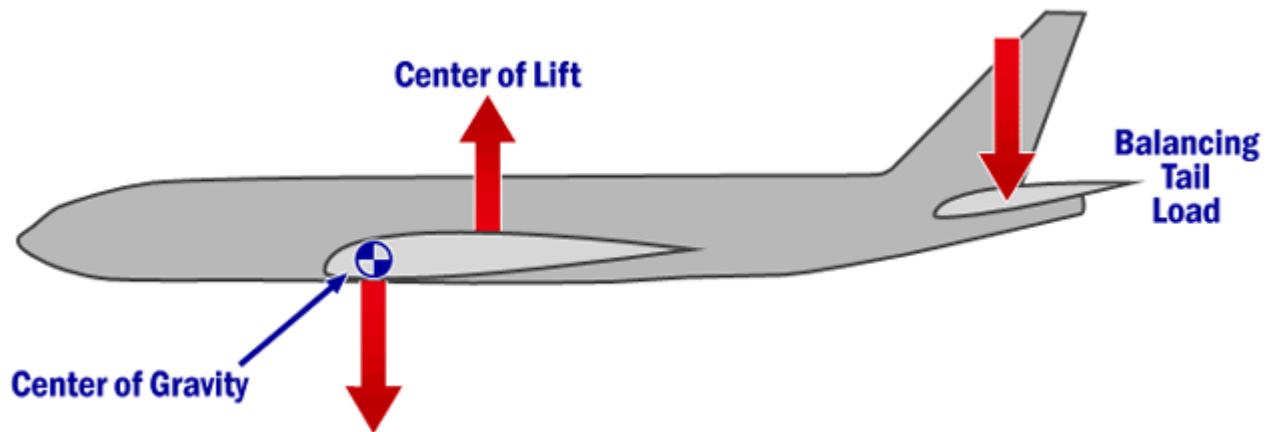
Figure 1.2.2 Diagram of locations of center gravity, center of lift, and balancing load of aircraft

The diagram below shows the relative locations of aircraft center of gravity, center of lift, and balancing tail load of a typical transport category aircraft in flight:

- The design of transport category aircraft results in a natural tendency to pitch the airplane nose down
- Balance (longitudinal stability) is provided by the downward acting force of the horizontal stabilizer
- Loss of the horizontal stabilizer results in an unbalanced nose-down pitch and loss of control

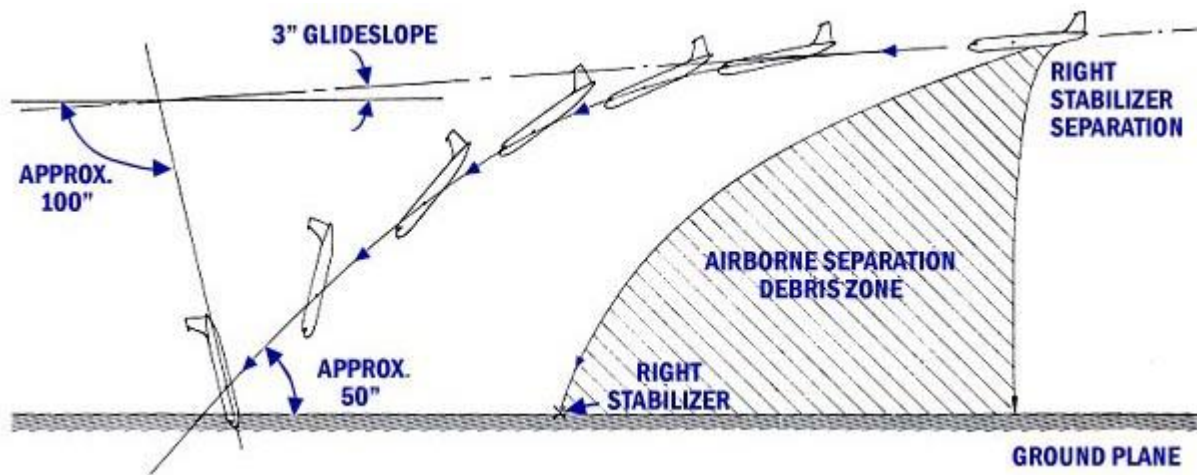
Figure 1.2.3 Diagram of Dan-Air accident, taken from accident report

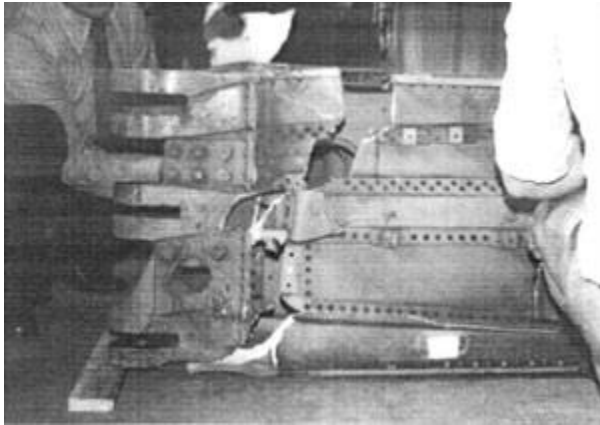
Figure 1.2.4 Photo of separation of Dan-Air right side stabilizer.
Accident investigation photo.

Examination of the detached stabilizer revealed evidence of a fatigue failure of the top chord of the rear spar, initiating at the 11th fastener hole, which is used by both the rear spar upper chord and upper skin structure. The location of the fastener was 14.25 inches outboard of the attachment of the stabilizer attachment pin.

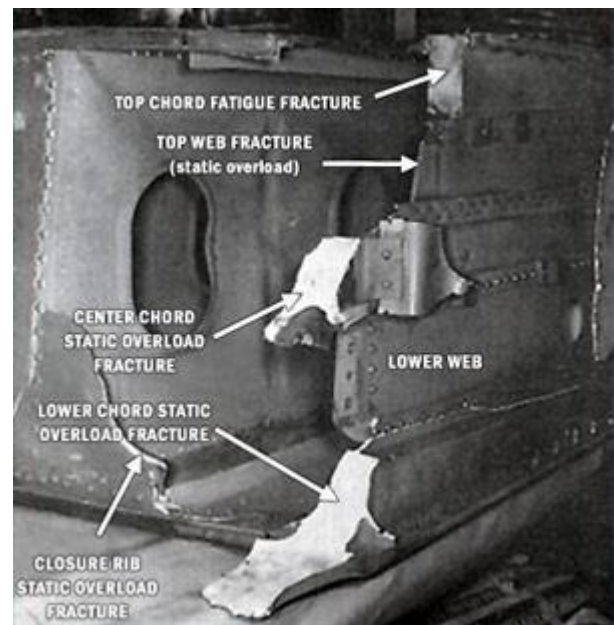
Figure 1.2.5 Photo of fracture face of Dan-Air accident aircraft right side horizontal stabilizer.

The cracking progressed in fatigue over approximately 60% of the chord, and then began a series of several tensile jumps, separated by small periods of fatigue. The total number of flights between the initiation of the fatigue crack and the final failure of the upper chord was estimated by the investigators to have been approximately 7,200 flights, with 3,500 of the flights being the duration to grow the crack across the exposed surface of the top chord.

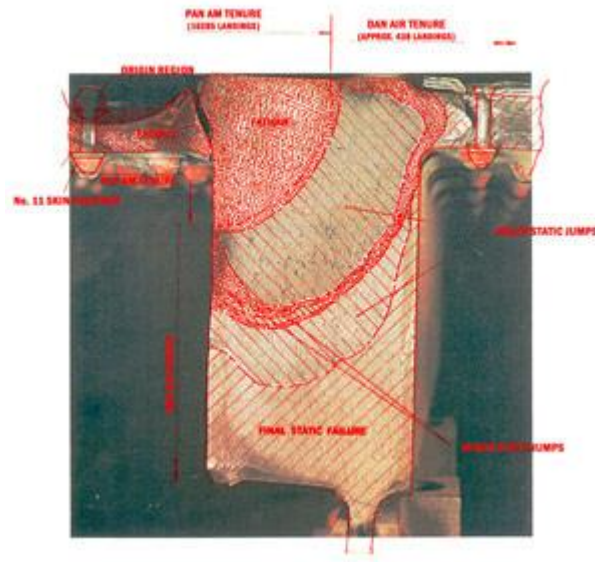
Figure 1.2.6 Photo of top chord fracture face, with crack progression identified.

The investigation discovered no unique feature leading to the cracking at the 11th fastener hole other than high stresses existing in the entire inboard area of the rear spar. The location of the 11th fastener hole is indicated by an arrow in the photo below.

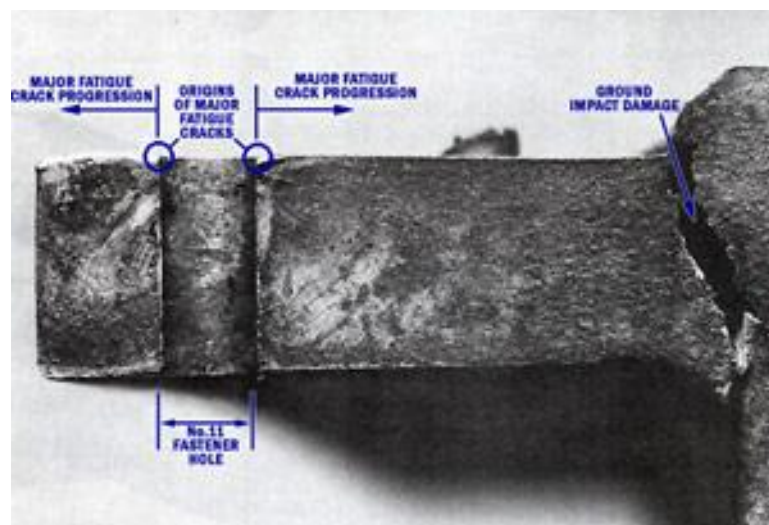
Figure 1.2.7 Photo of fracture face emanating from the 11th fastener

Post-accident inspection of the 707-300 in-service fleet discovered cracking occurring in the rear spar upper chord at the 11th fastener in three other aircraft. Cracks were also found in other fastener holes on either side of fastener hole 11, from holes 2 to 21. In total, cracks were found in 7% of the in-service fleet, equal to 38 of the 521 model 707-300s in operation.

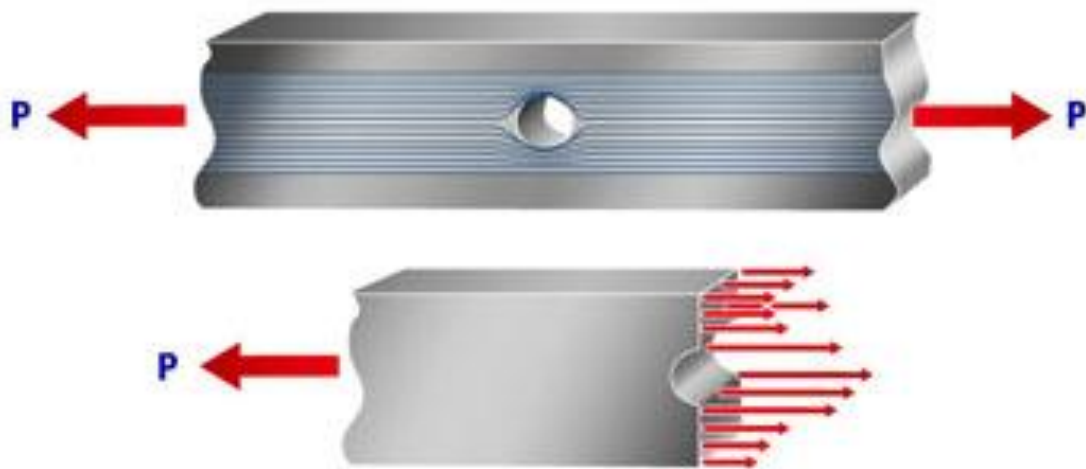
Figure 1.2.8 Diagram of stress concentration

A structural member having a discontinuity, such as a fastener hole, will develop a stress field that is larger at the edges of the hole. This means that the stresses are higher at the edges of the hole than in the area away from the hole. This phenomenon is called a "stress concentration," and explains one of the causes of cracking typically found to occur at the location of the discontinuity.

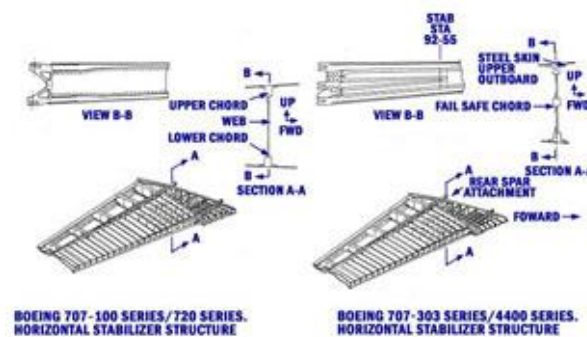
Figure 1.2.9 Diagram of horizontal stabilizer structure
(View Large Diagram)

When the model 707-300 was developed, the stabilizer assembly was extensively redesigned. The stabilizer span was enlarged to increase tail volume. To accommodate the resulting increase in loading on the larger tail, the intended fail-safe characteristic of the structure was achieved by the addition of a third chord, with a lug and clevis attachment point, located at mid-spar depth on the rear spar.

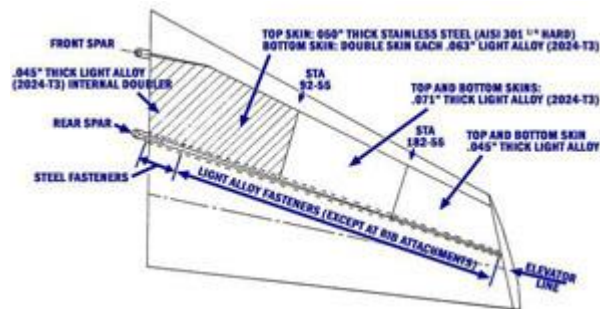
Figure 1.2.10 Diagram of the stabilizer lower aluminum skin thickness

Another design change was made to the 707-300 as a result of a discovery made during the flight test program. Flight testing indicated that the 707-300 horizontal stabilizer lacked sufficient torsional stiffness. In order to correct this deficiency, the stabilizer lower aluminum skin was increased in thickness, and a stainless steel plate was used to replace a portion of the upper aluminum skin. The location of the stainless steel plate is shown as the shaded area on the figure below.

The stainless steel plate was much stiffer than the aluminum structure to which it was attached. Without the plate, the aluminum horizontal stabilizer would deflect a certain amount under flight loading. With the stainless steel plate riveted to the stabilizer, the deflection was less because the steel plate resisted the bending. This bending resistance was transferred to the aluminum stabilizer rear spar through higher-than-expected loading in the fasteners.

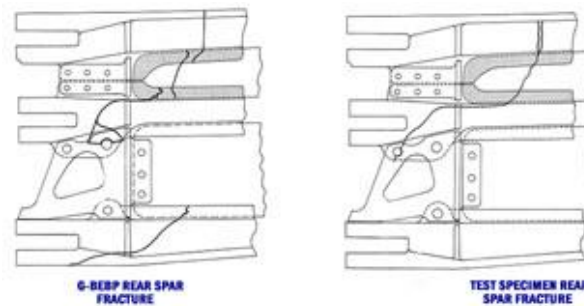
Figure 1.2.11 Diagram of rear spar fracture
(View Large Diagram)

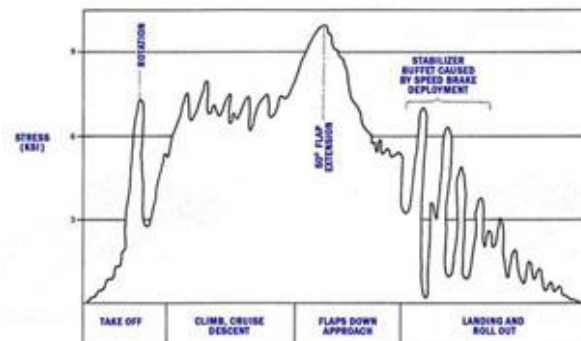
Figure 1.2.12 Diagram of the horizontal stabilizer load spectrum
(View Large Diagram)

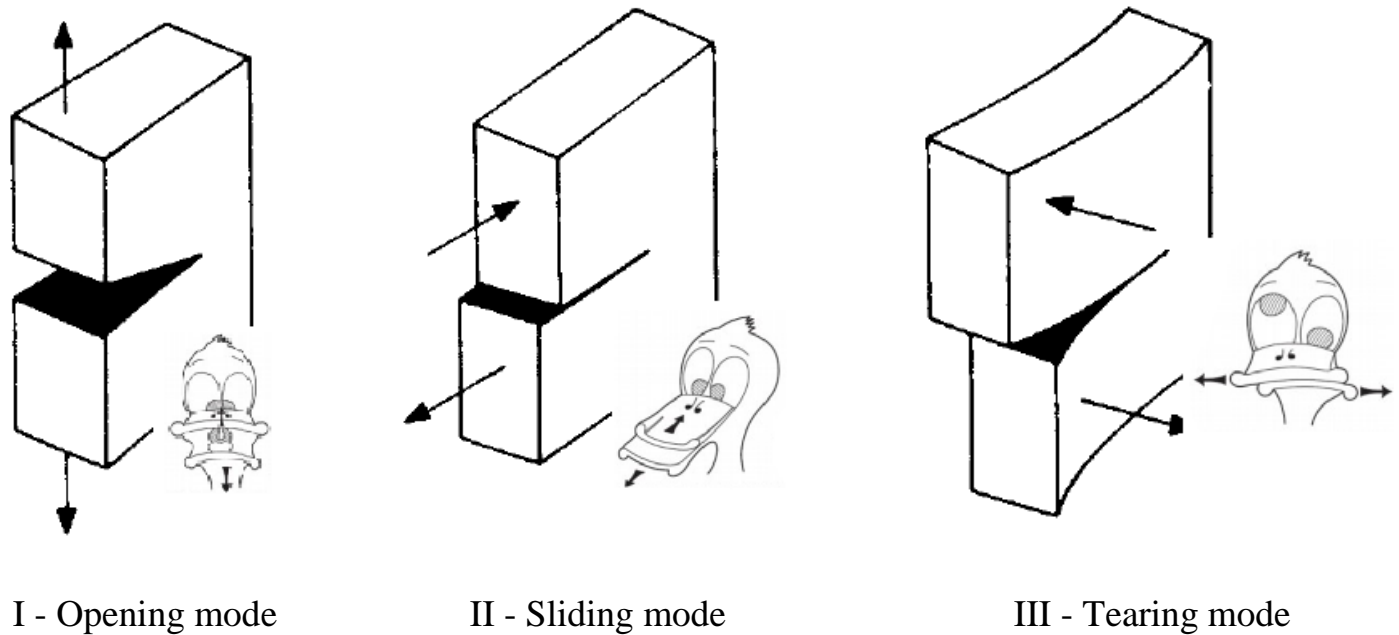
Fig. 2.1.1 The three modes of cracking

In the most general case, the distribution of deformations in the vicinity of an arbitrary point of the crack contour can be represented as a superposition of three particular types of deformation (Fig. 2.1.1), corresponding to the three main types of displacement of the crack surfaces: normal detachment (I), transverse (II), and longitudinal (Iii) shifts. The first type is associated with the normal displacement of the crack surfaces in mutually opposite directions; the second corresponds to displacements

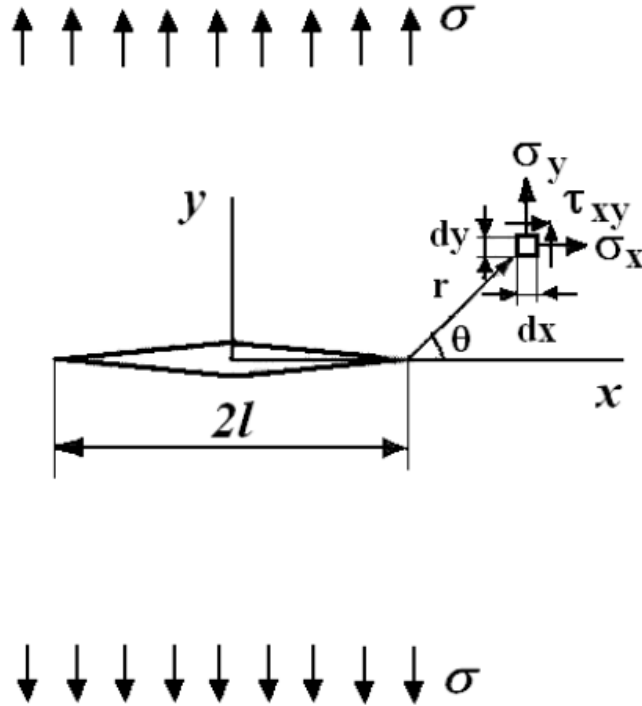
Fig. 2.1.2 Endless plate crack

Consider a through crack of type I with a length of $2l$ in an infinite plate, as shown in Fig. 2.1.2

The plate is under the action of tensile stress σ , which is caused by forces applied at infinity. The $dxdy$ element of the plate, located at a distance r from the crack tip and making an angle θ with the plane of the crack, is affected by normal stresses σ_x and σ_y , acting in the x and y directions and tangential stress τ_{xy} . It can be shown that these stresses are equal:

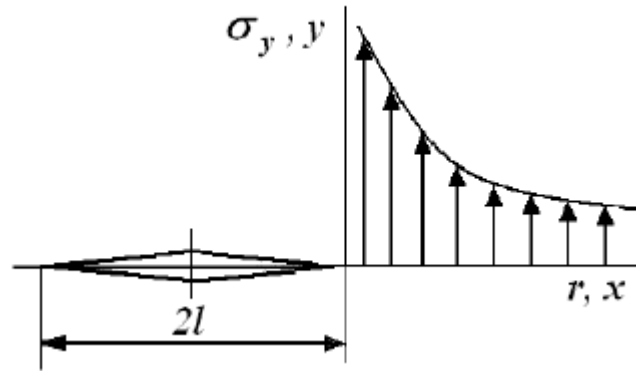
Fig. 2.1.2 Elastic stress σ_y at the crack tip.

In the elastic case, the stresses indicated in (2.1.1) are proportional to the external stress σ . Their values are proportional to the square root of the crack size and tend to infinity at the crack tip when r vanishes. The dependence of σ_y on r for $\theta = 0$ is shown in Fig. 2.1.3.

For large values of r , the quantity σ_y tends to zero, while it should tend to σ . Obviously, equations (2.1.1) are valid only in a limited region - near the crack tip. Each of the equations is the first member of the series.

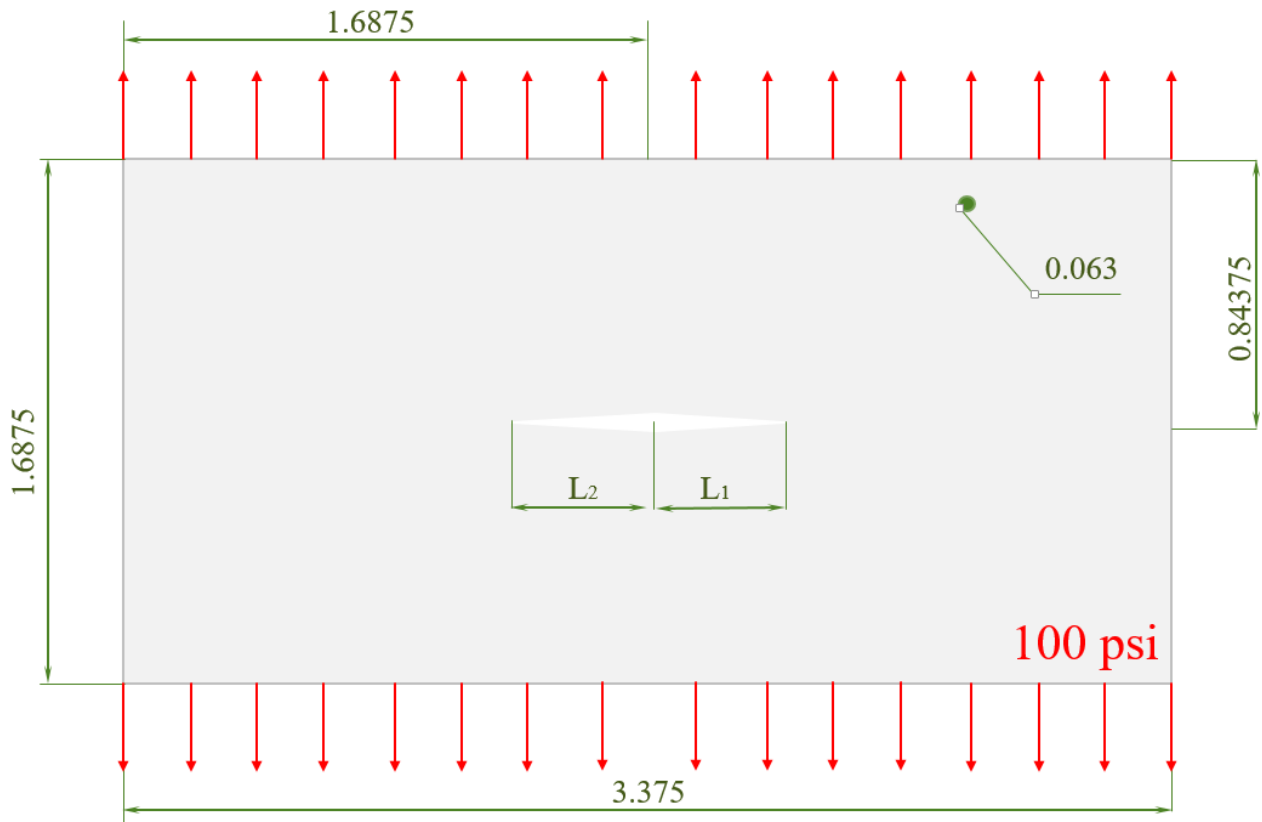
Fig. 3.1 Geometric parameters and Loads

There is a plate of skin, typical open hole with crack. Plate is fabricated from Aluminum 2024 – T3, Clad Sheet. It has 0.063 inch thick and 3.375 inch in longitudinal direction (X axis) and 1.6875 inch in hoop direction(Y axis) figure 3.1 .

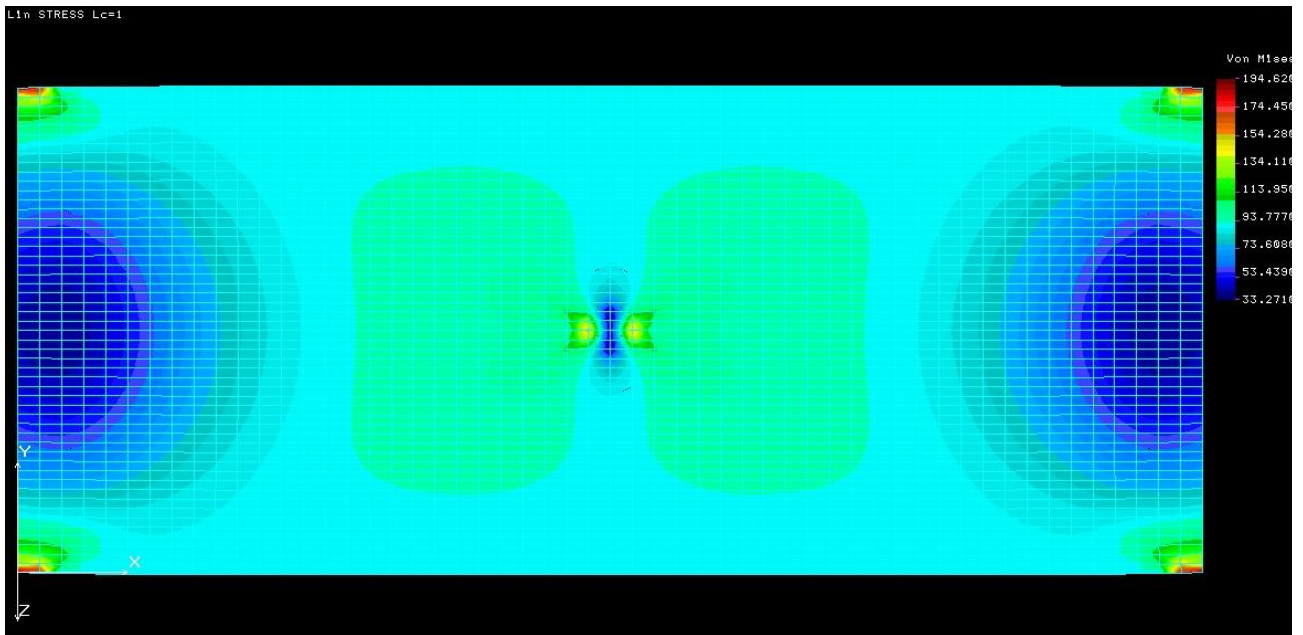
Fig. 3.3 Stress Von Mises in Stage 1

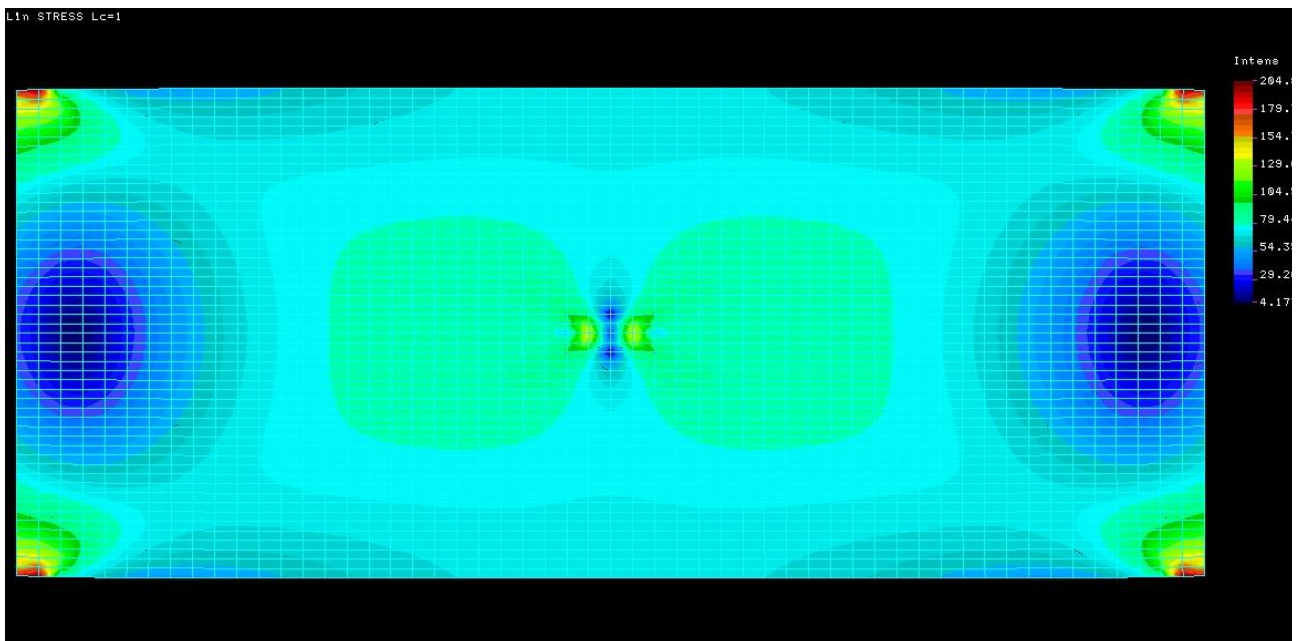
Fig. 3.4 Stress Intensity in Stage 1

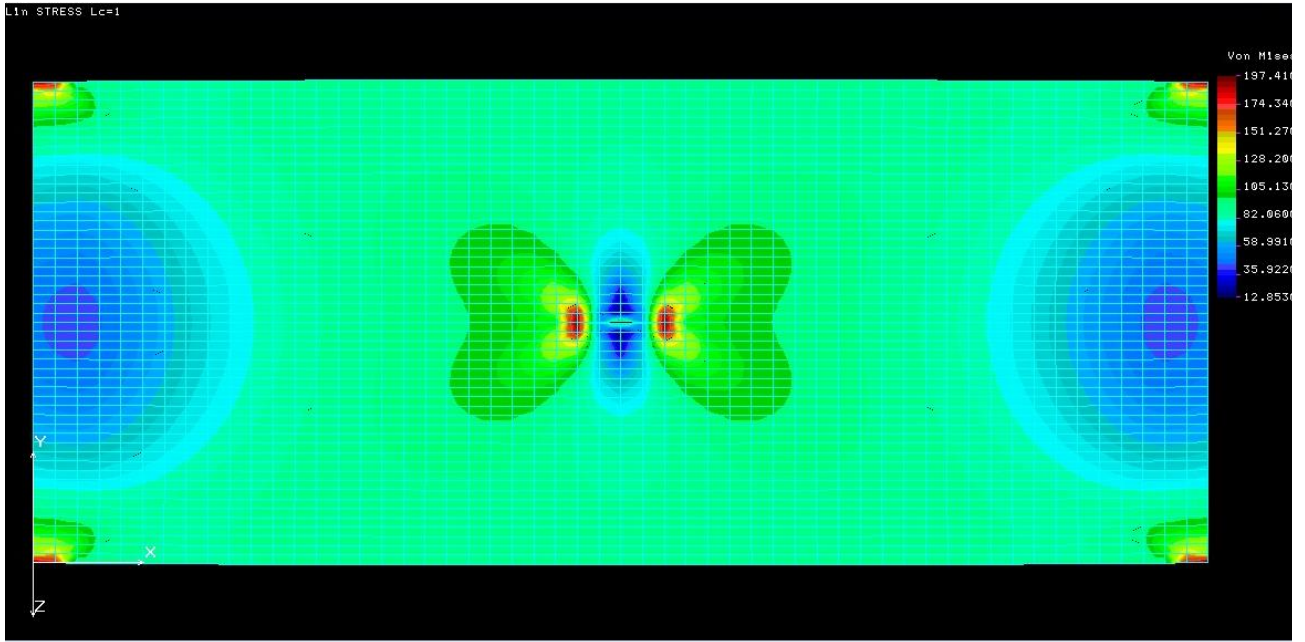
Fig. 3.5 Stress Von Mises in Stage 2

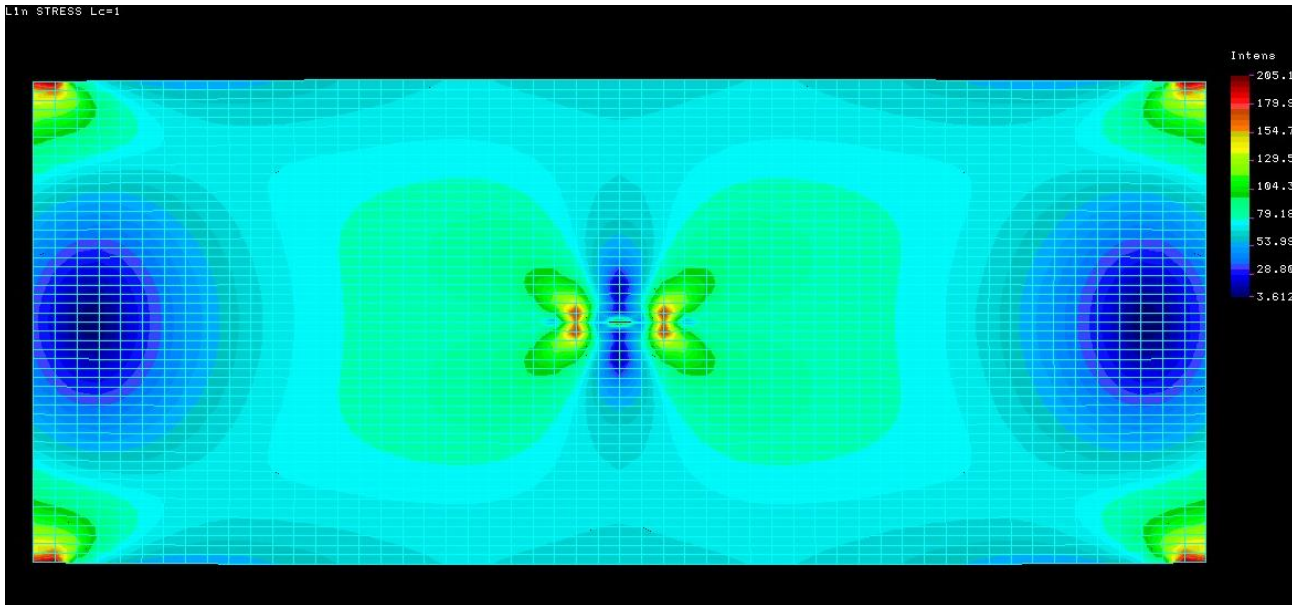
Fig. 3.6 Stress Intesity in Stage 2

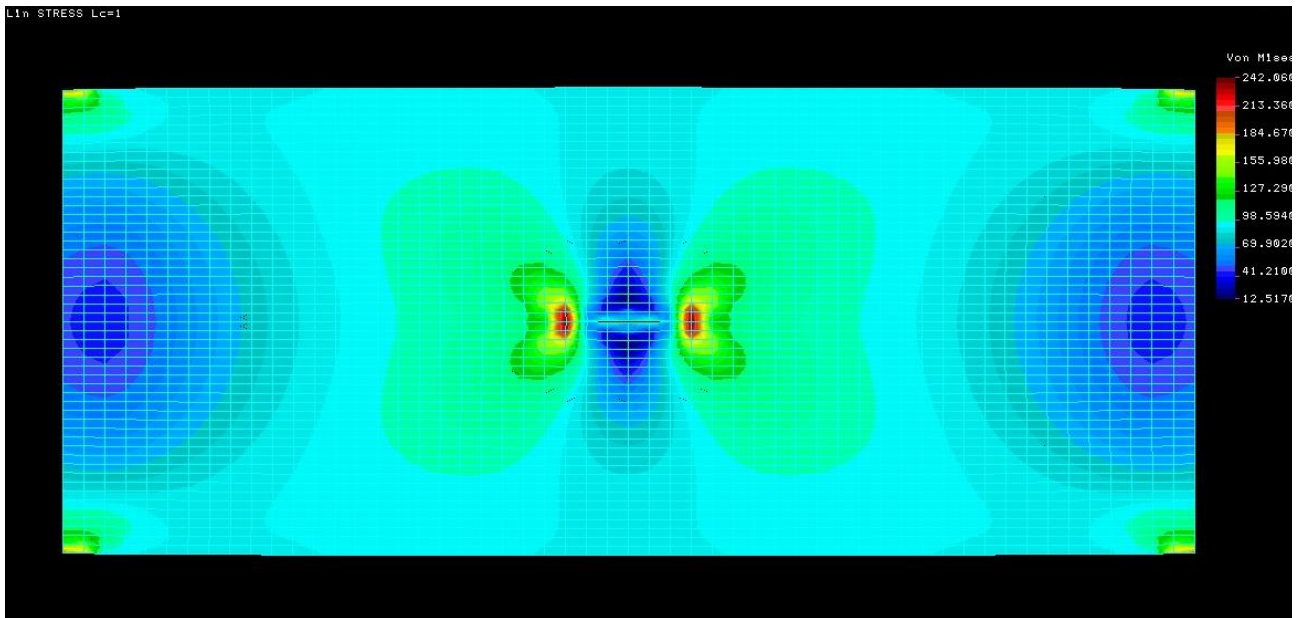
Fig. 3.7 Stress Von Mises in Stage 3

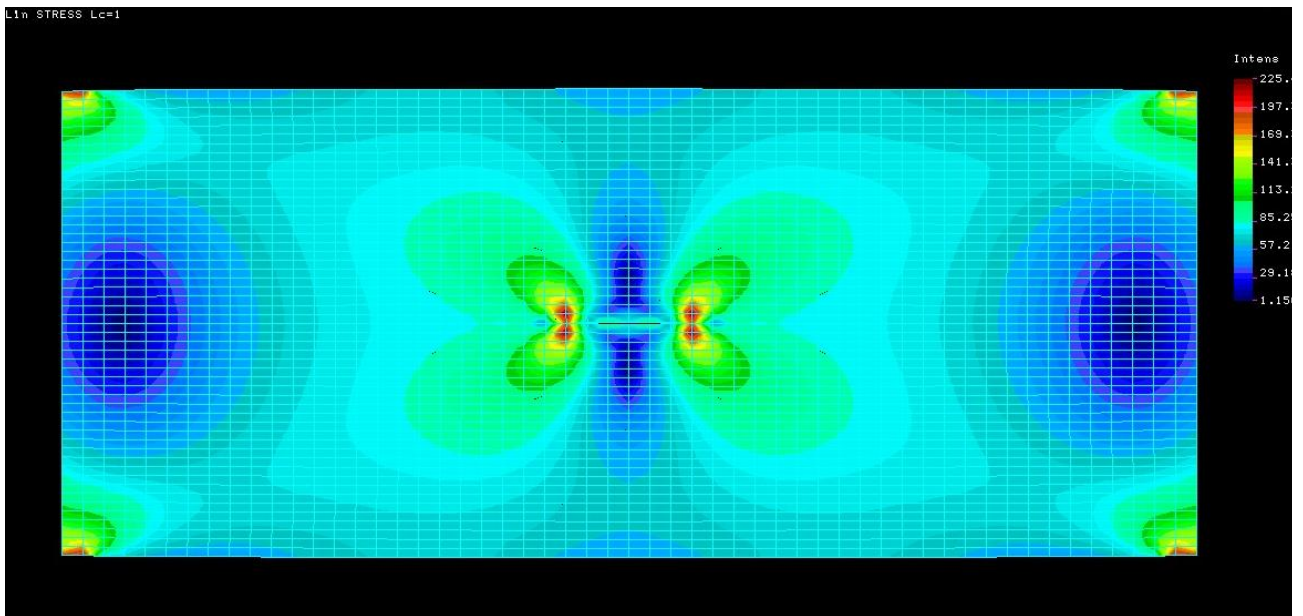
Fig. 3.8 Stress Intensity in Stage 3

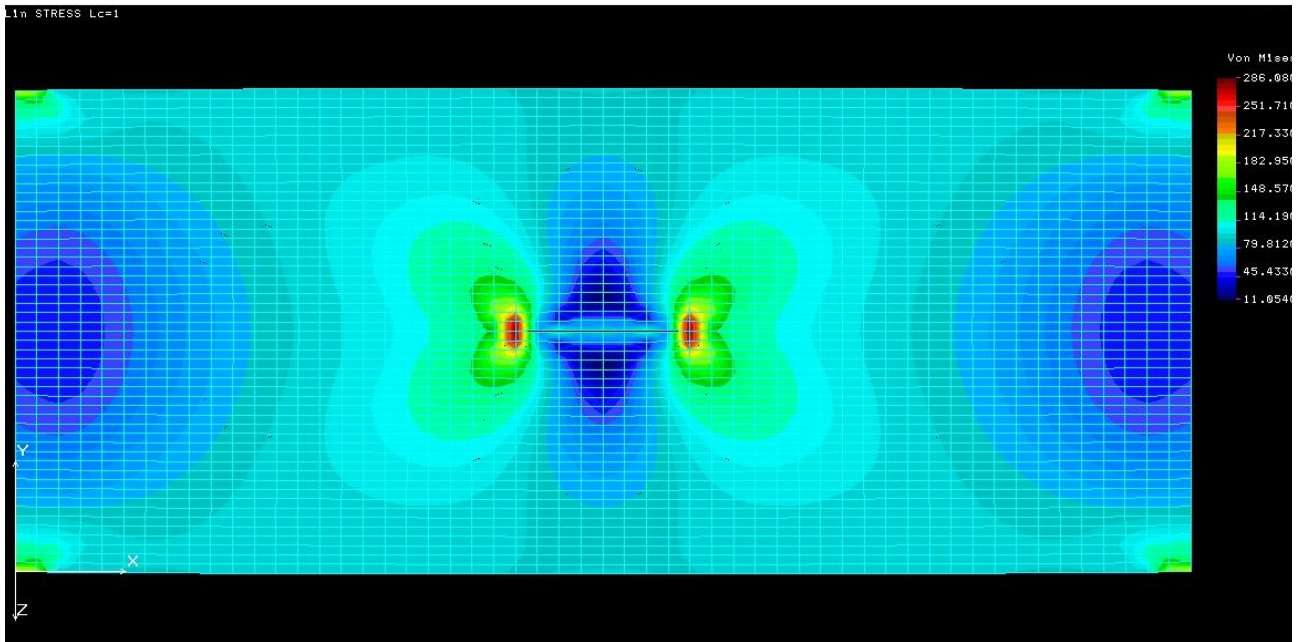
Fig. 3.9 Stress Von Mises in Stage 4

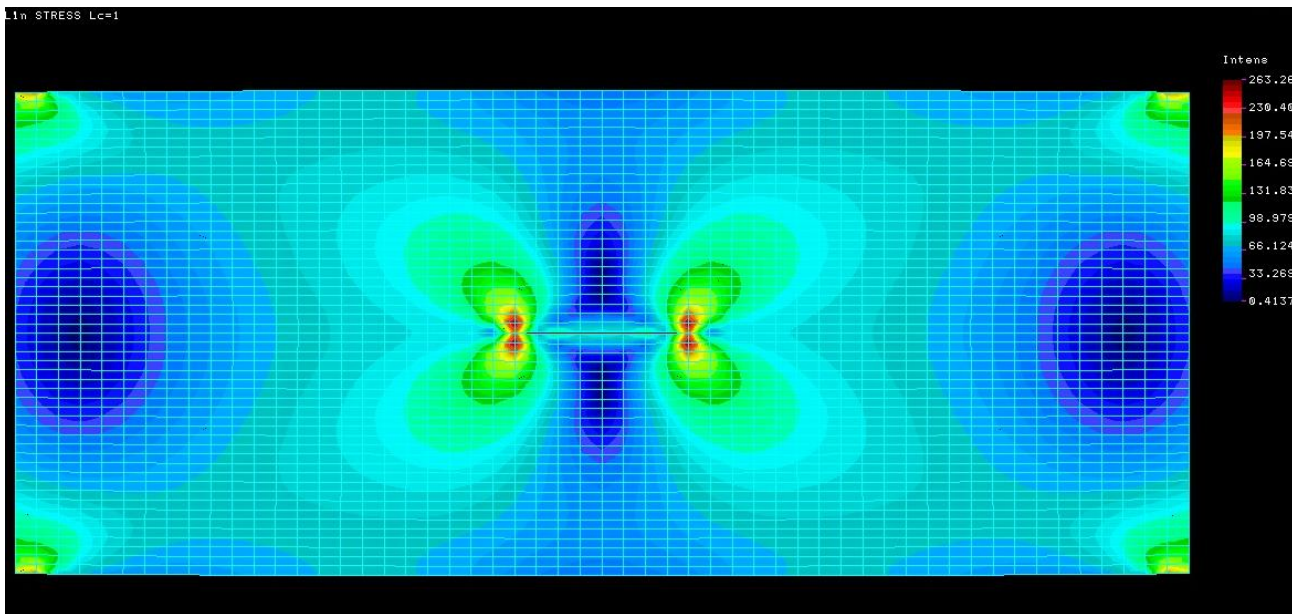
Fig. 3.10 Stress Intensity in Stage 4

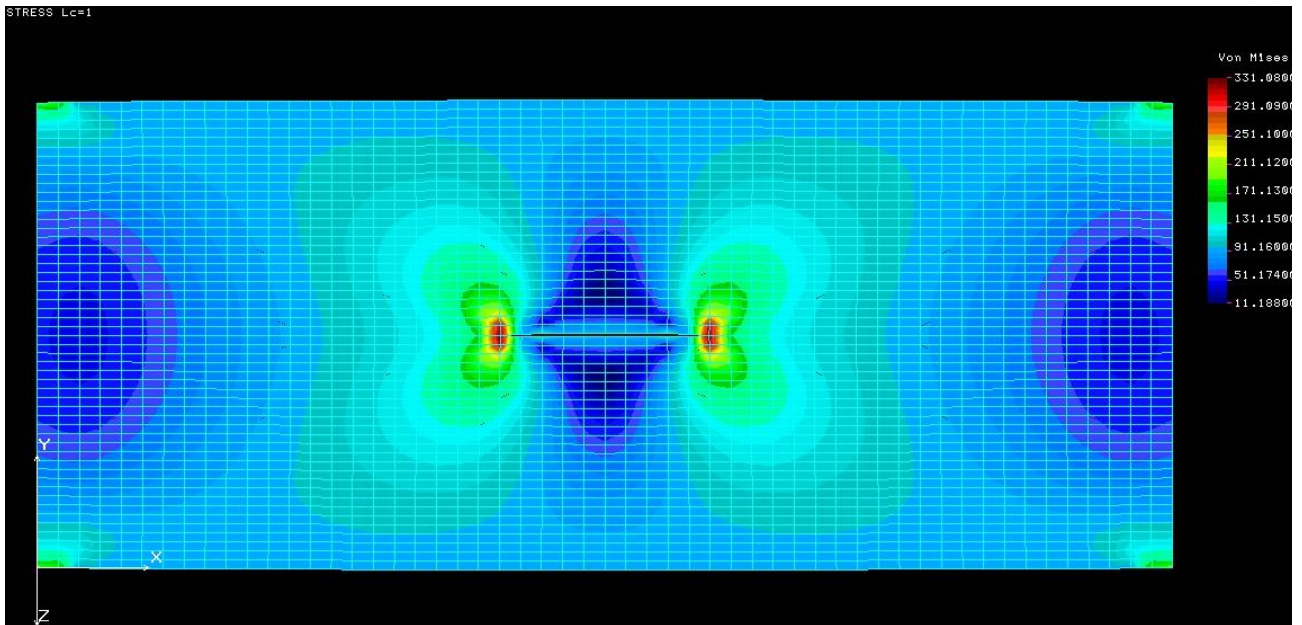
Fig. 3.11 Stress Von Mises in Stage 5

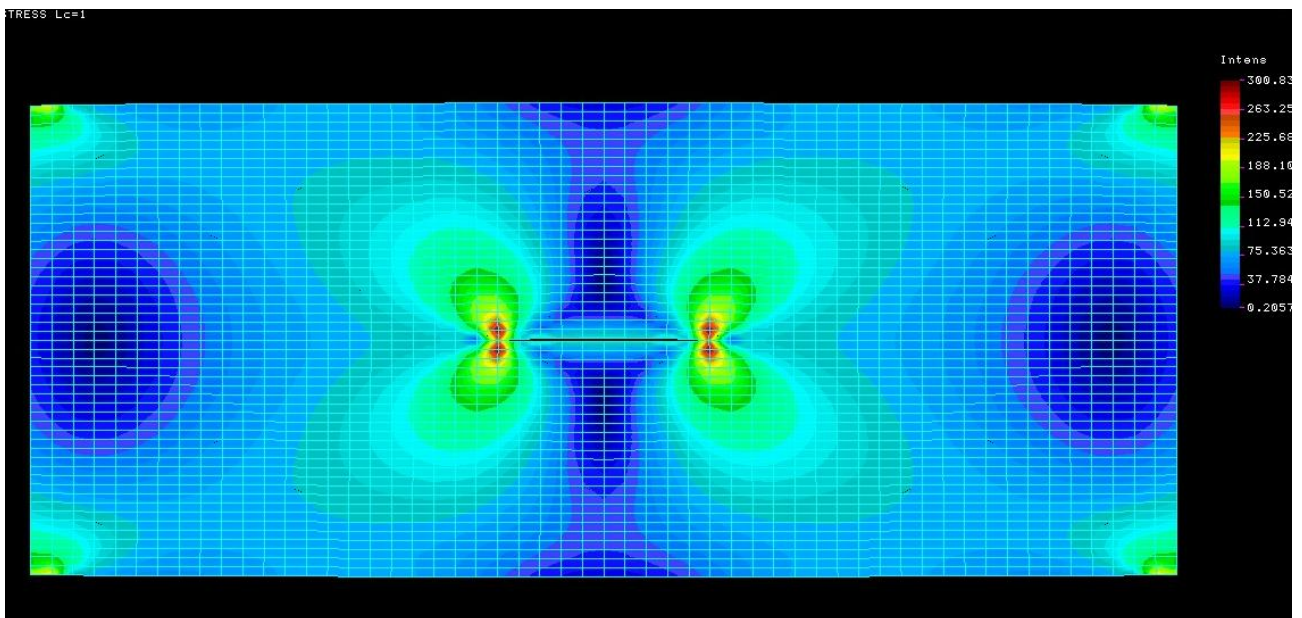
Fig. 3.12 Stress Intensity in Stage 5

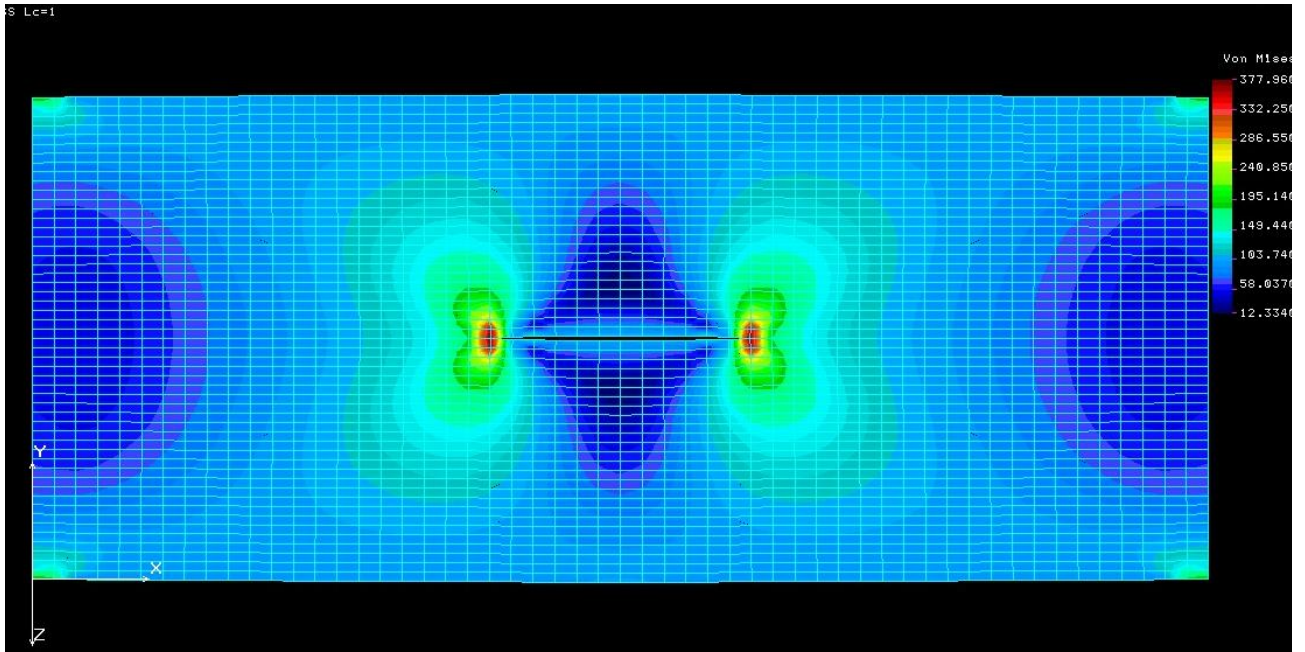
Fig. 3.13 Stress Von Mises in Stage 6

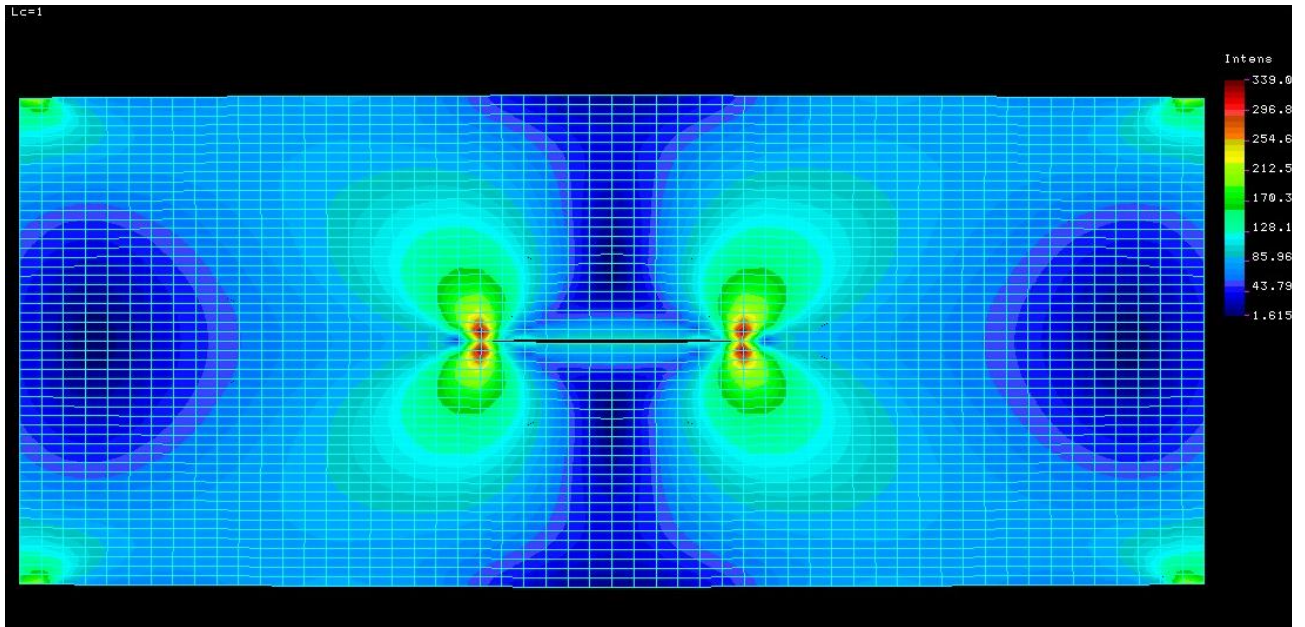
Fig. 3.14 Stress Intensity in Stage 6

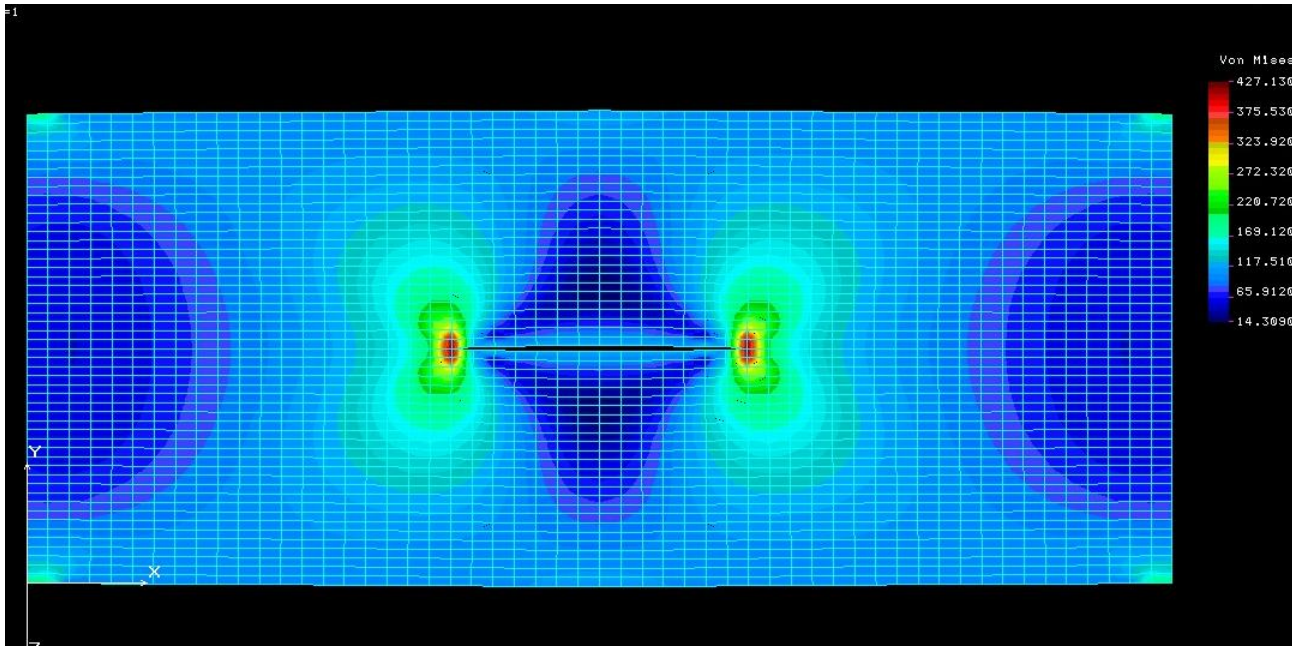
Fig. 3.15 Stress Von Mises in Stage 7

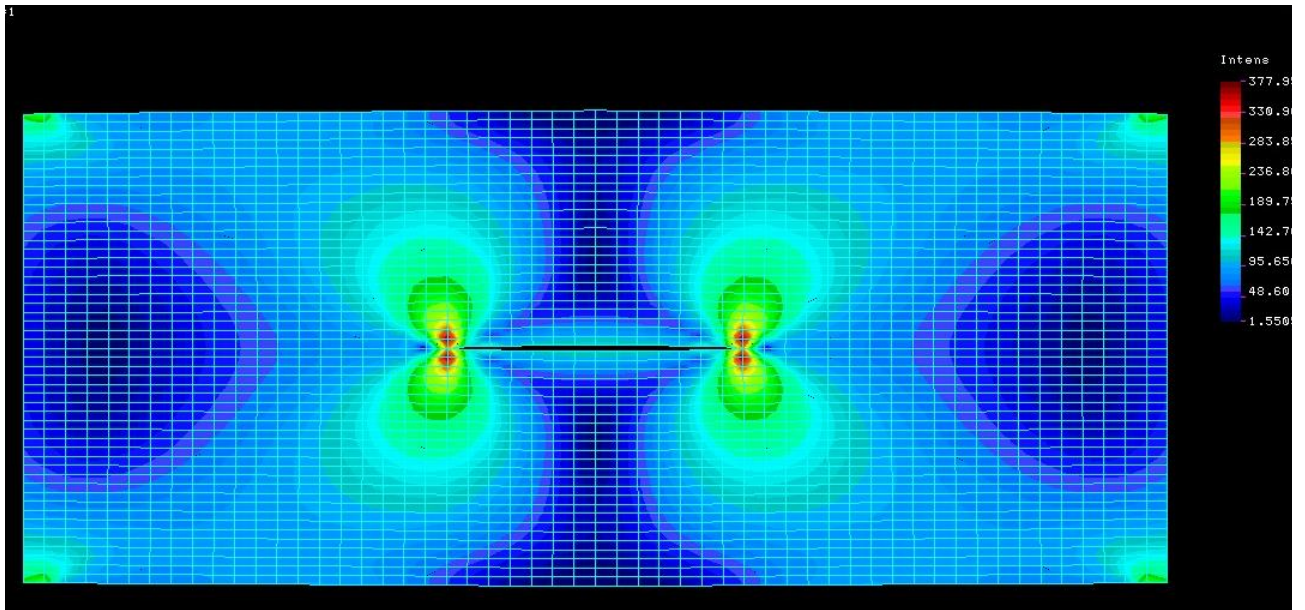
Fig. 3.16 Stress Intensity in Stage 7

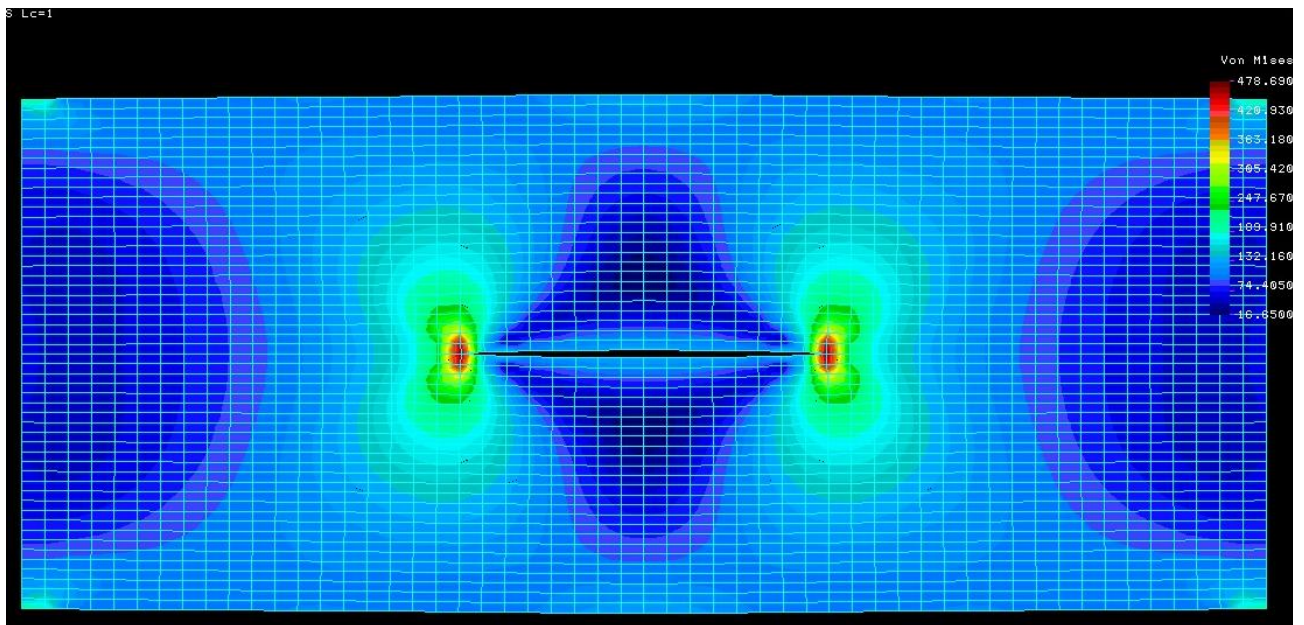
Fig. 3.17 Stress Von Mises in Stage 8

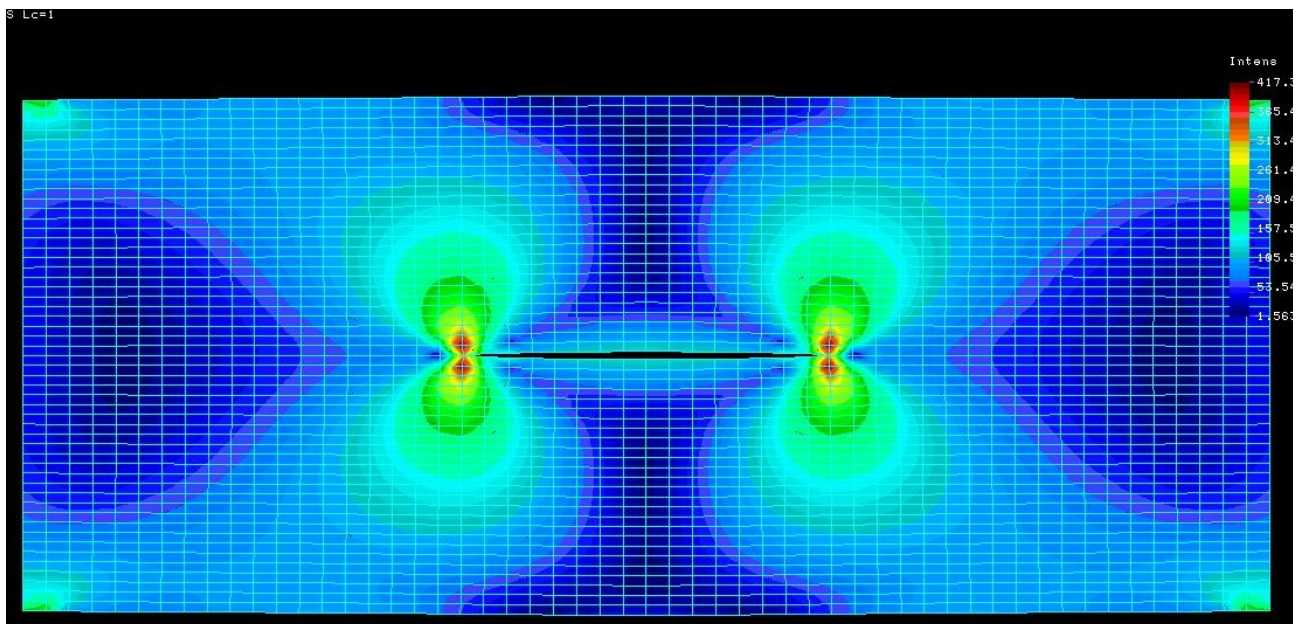
Fig. 3.18 Stress Intensity in Stage 8
