МАГІСТЕРСЬКА ДИСЕРТАЦІЯ

на тему: Напружено-деформований стан в зоні вершини магістральної тріщини в обшивці фюзеляжу пасажирського літака

The object of the work is the skin with main crack for passenger aircraft.

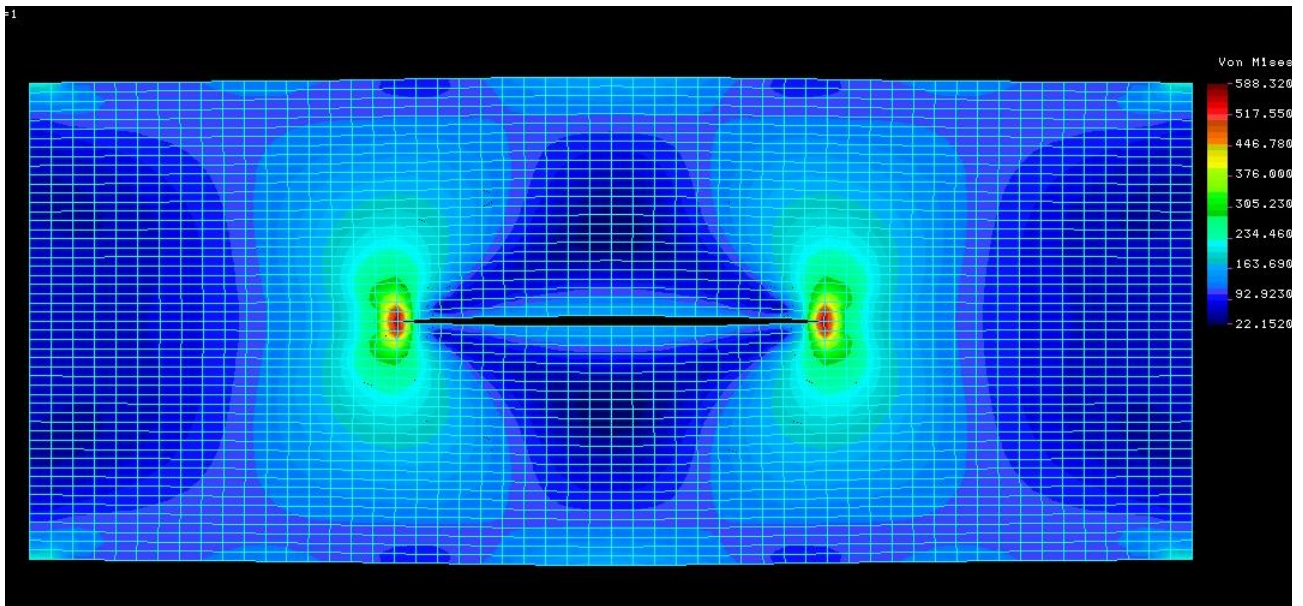
Fig. 3.21 Stress Von Mises in Stage 10

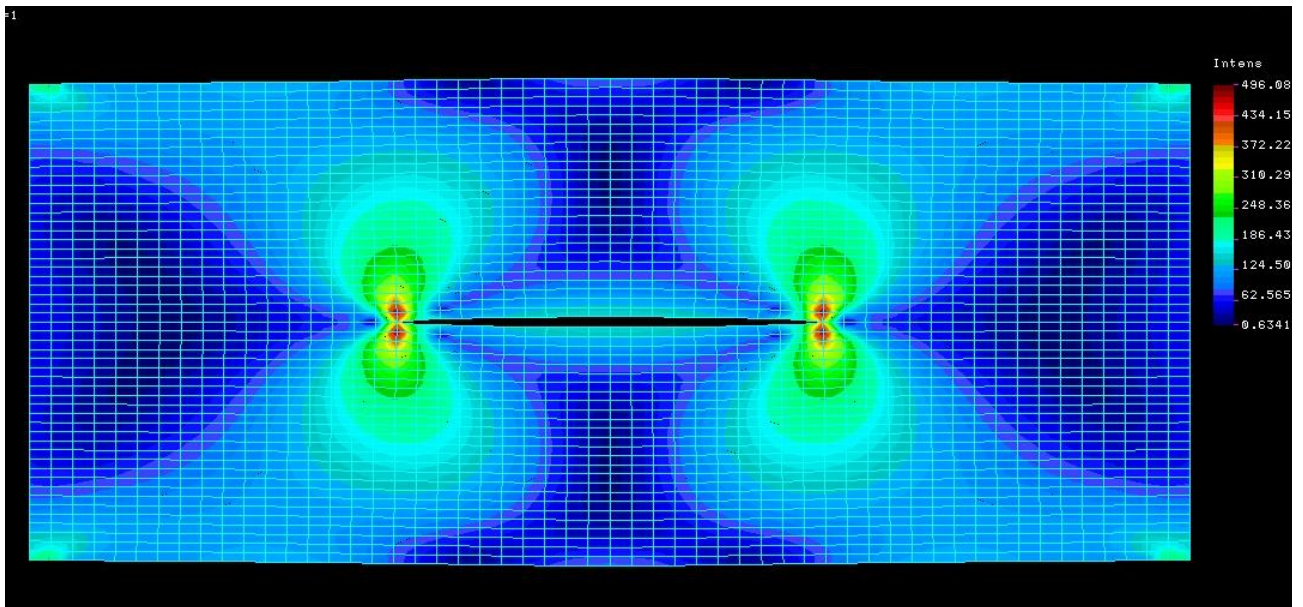
Fig. 3.22 Stress Intesity in Stage 10

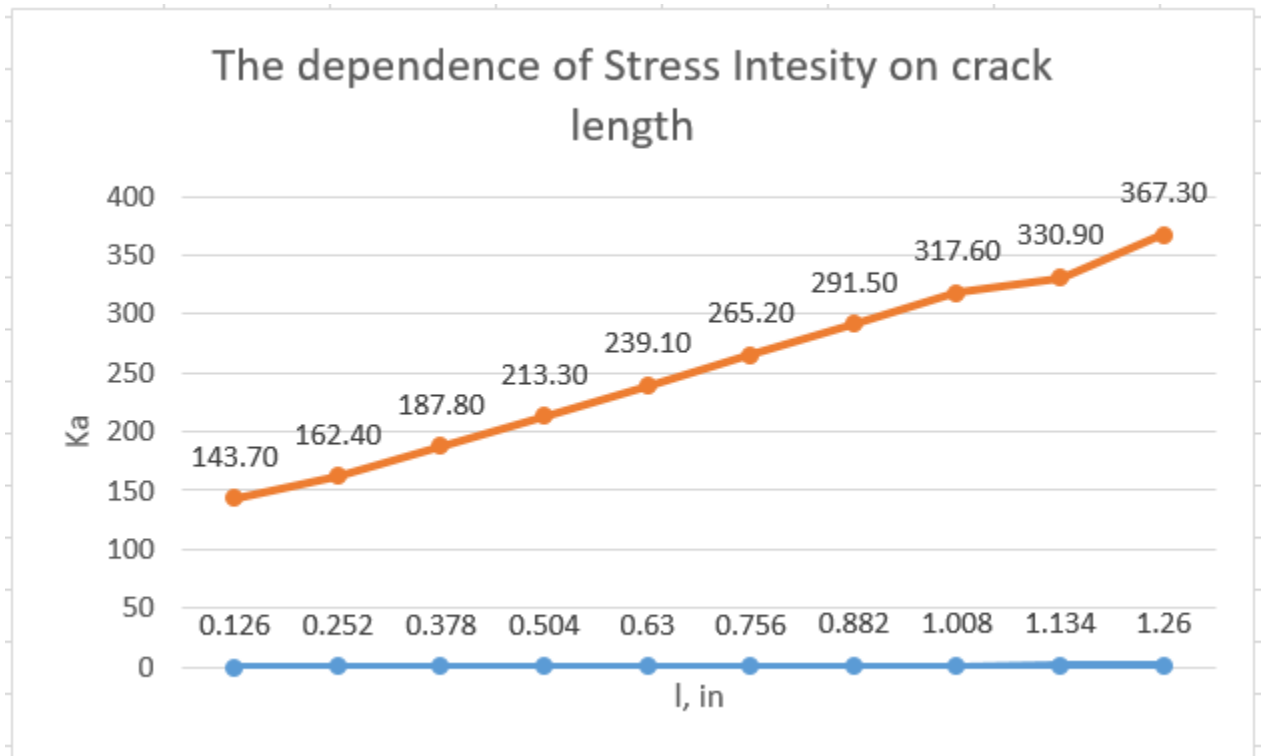
Dependence of the SIF on the length of the crack l .

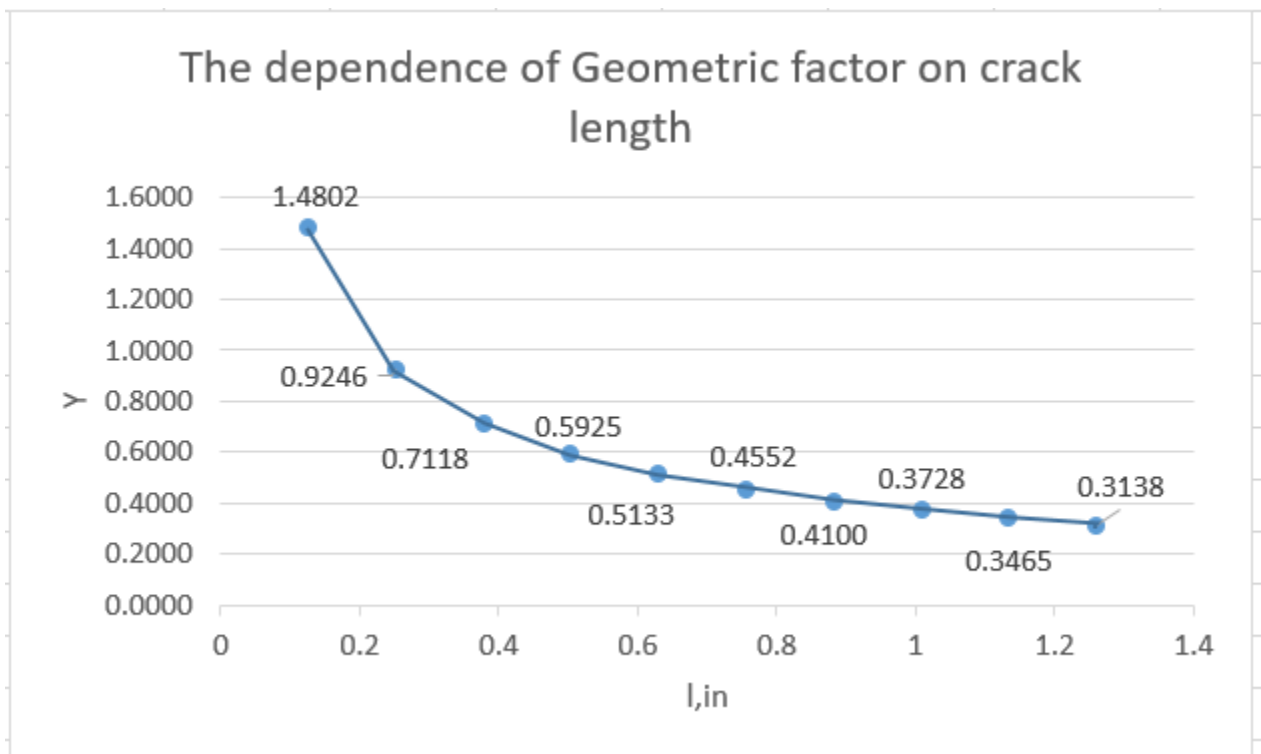
Dependence of the Y-factor on the length of the crack l .
